Latest Firmware version issued on 14th, August, 2020, please check carefully before updating, please check the modifications in blue color, please check your radio version carefully, if serial number after 2006T00001 and 2006U00001, it should be new version, 2006T00001 and 2006U00001 means it is released in year 2020, June

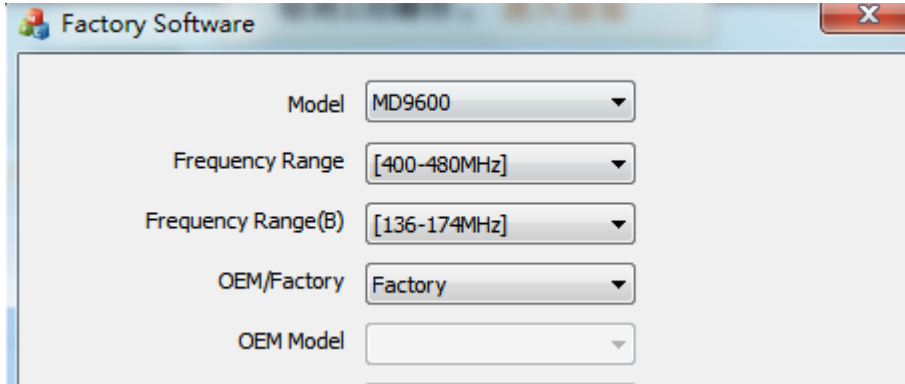
And some ham will find the radio have only one band after upgrading, so please write also with this factory, please write above one UHF and below one VHF

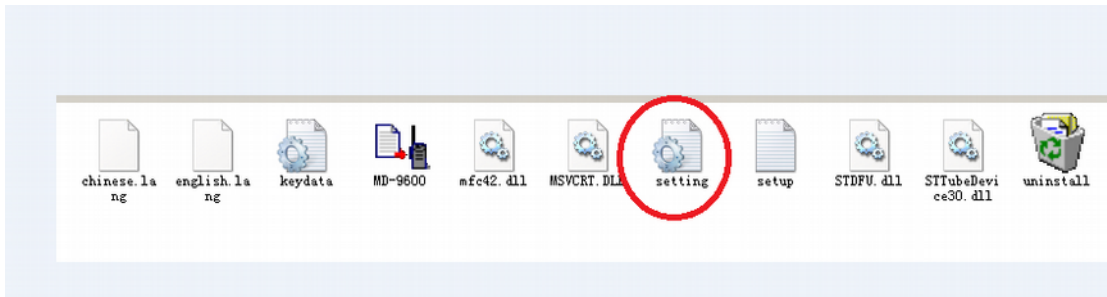
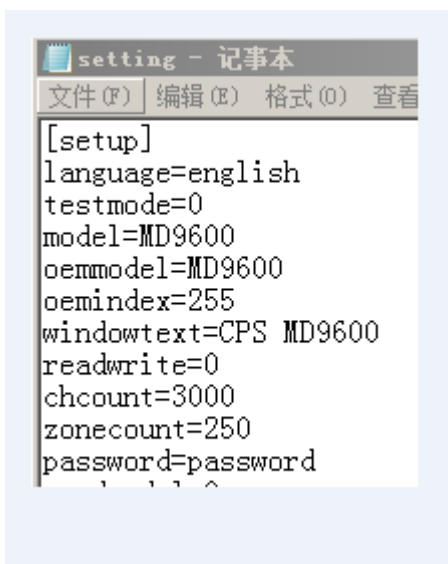
And some users also found that the radio will show enter password even you didnt set the password after upgrading, please set password=0 in the programming software into password=password
